#13: Crushed by/ struck by – Inspection #1072840

A **38 year old male** employee was fatally injured when he was ejected from a skid steer. The victim was contracted by the controlling contractor for storm debris removal after an ice storm in Cumberland County. A Manitou Telehandler skid steer, with a grab bucket, was provided by the controlling contract and operated by the victim. The victim and his crew had been working on this project for approximately four weeks prior to the accident. On the day of the accident the victim was operating the Manitou downhill on a two lane highway when the drive shaft broke. It is believed the victim thought he could safely come to a stop by steering the Manitou off the road into a yard adjacent to the highway. A ditch running parallel to the highway was concealed from the operators view by overgrown grass and weeds. The Manitou gained momentum as it traveled down the hill, left the road, and hit the ditch. The out of control the Manitou traveled further in the yard hitting a second ditch and then a tree before coming to rest on its left side. The victim was ejected. There were no skid marks on the highway to indicate the victim applied the brake

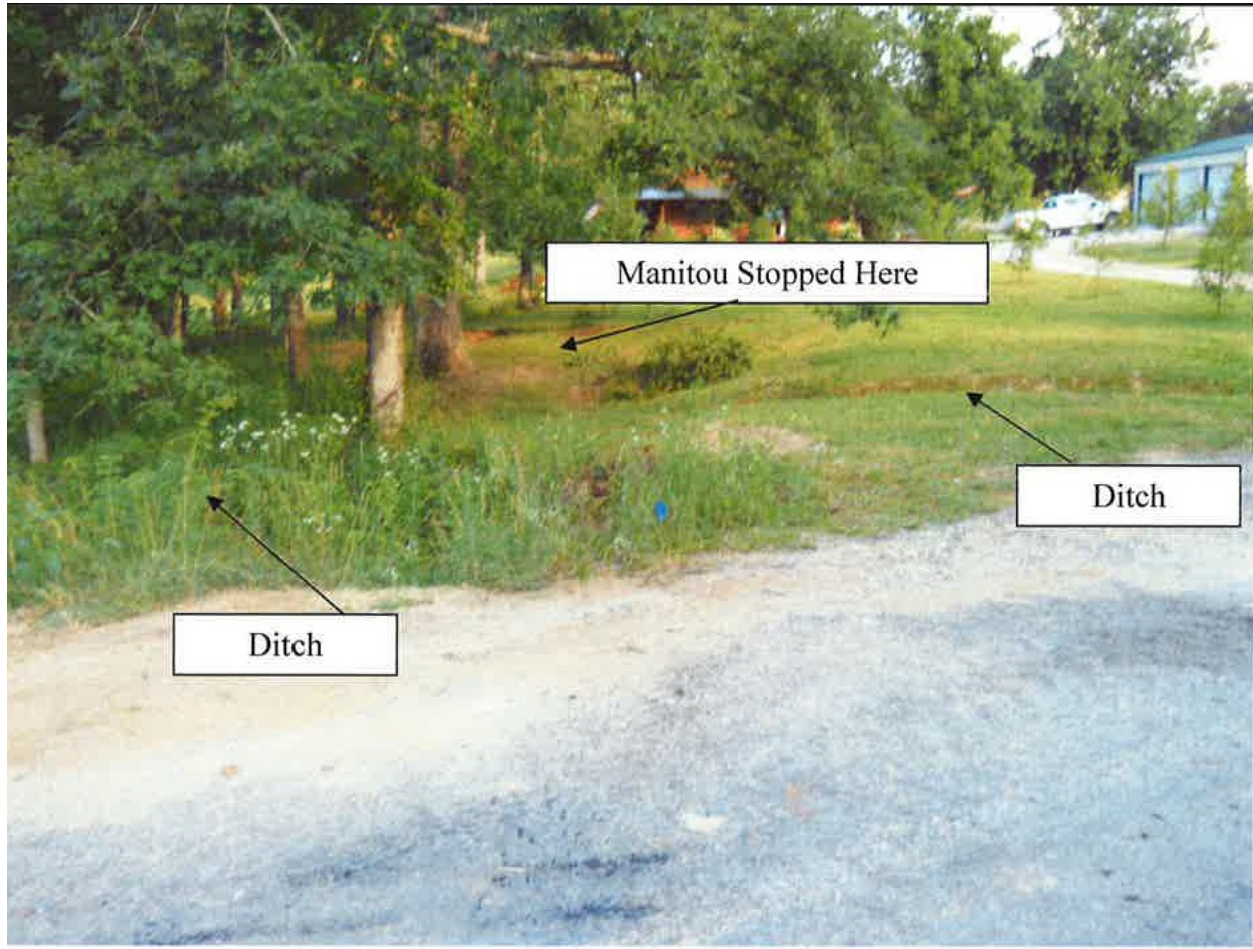
Photo 1 of 2 – This photo shows where the skid steer rolled over on its side and the ditch that was involved with the crash.

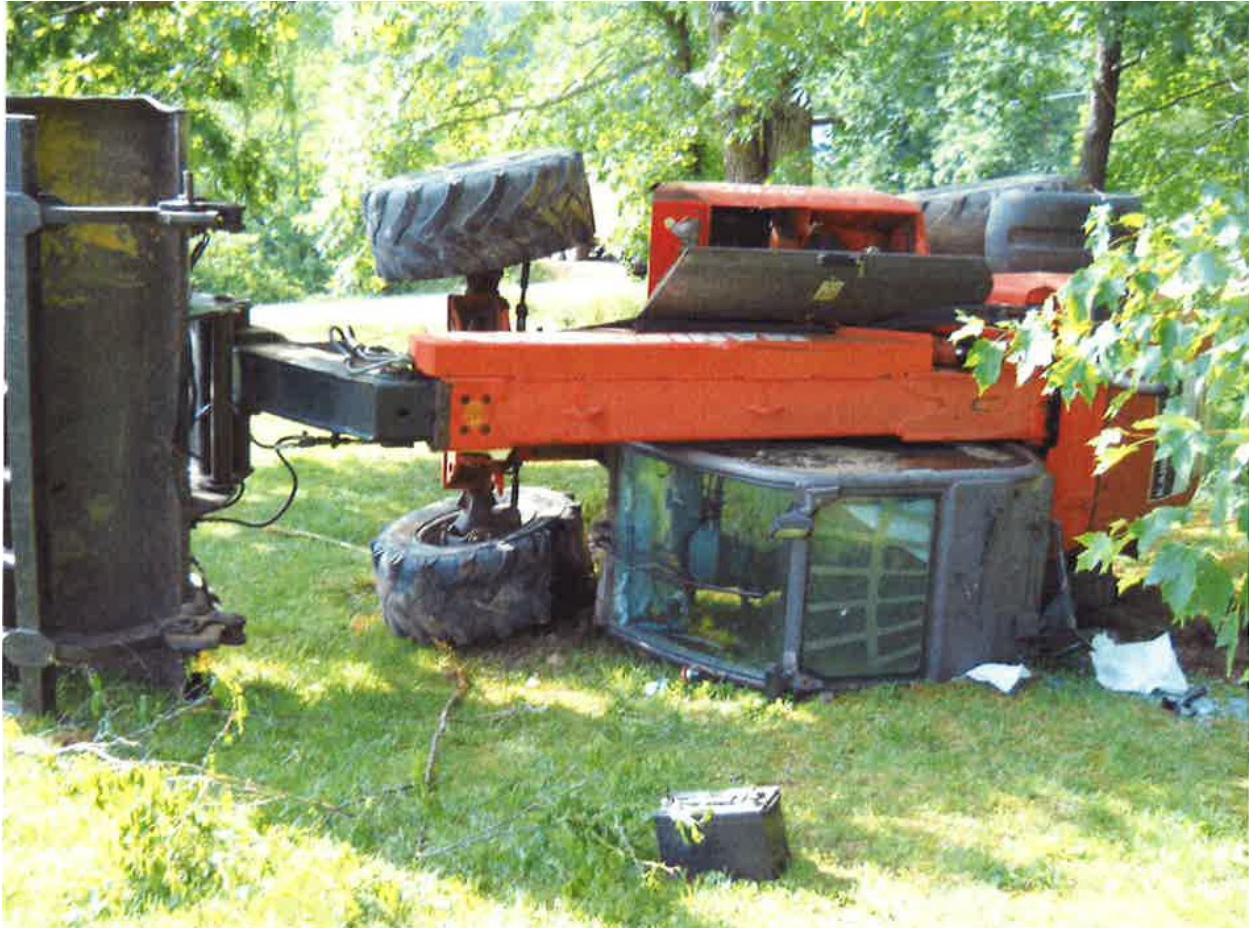
Photo 2 of 2 – This photo shows where the skid steer rolled over on its left side.
